Reason and Solution behind Ghost Touch Issues on iPad Air Digitizer

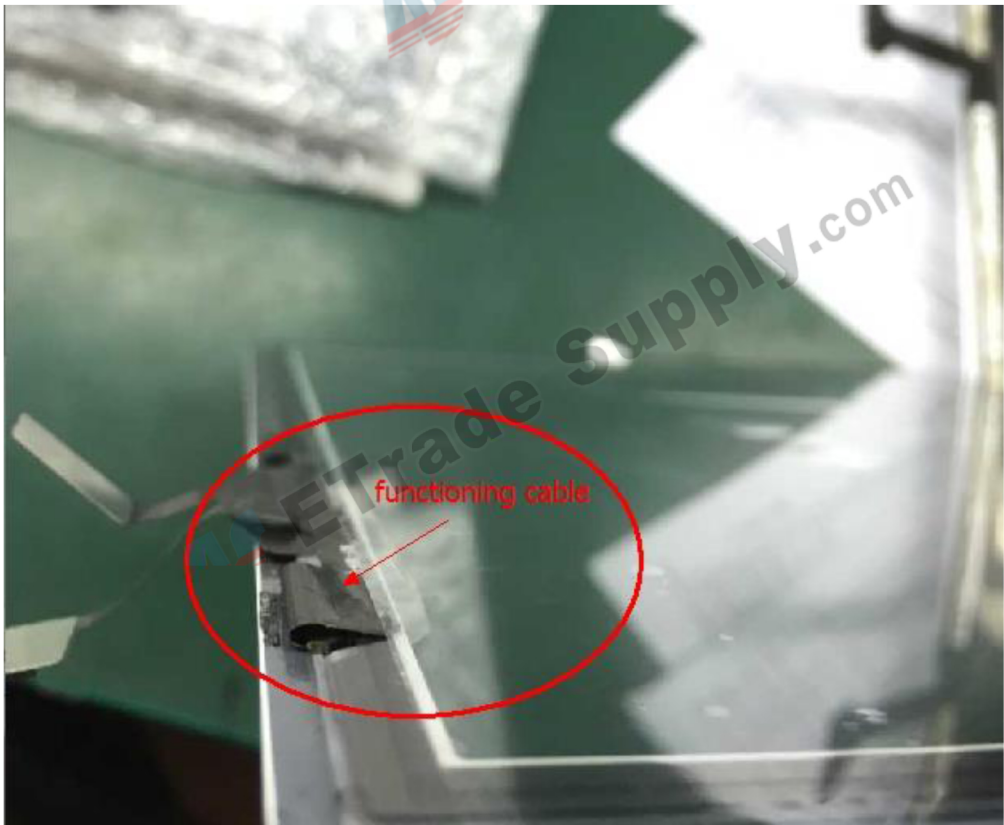
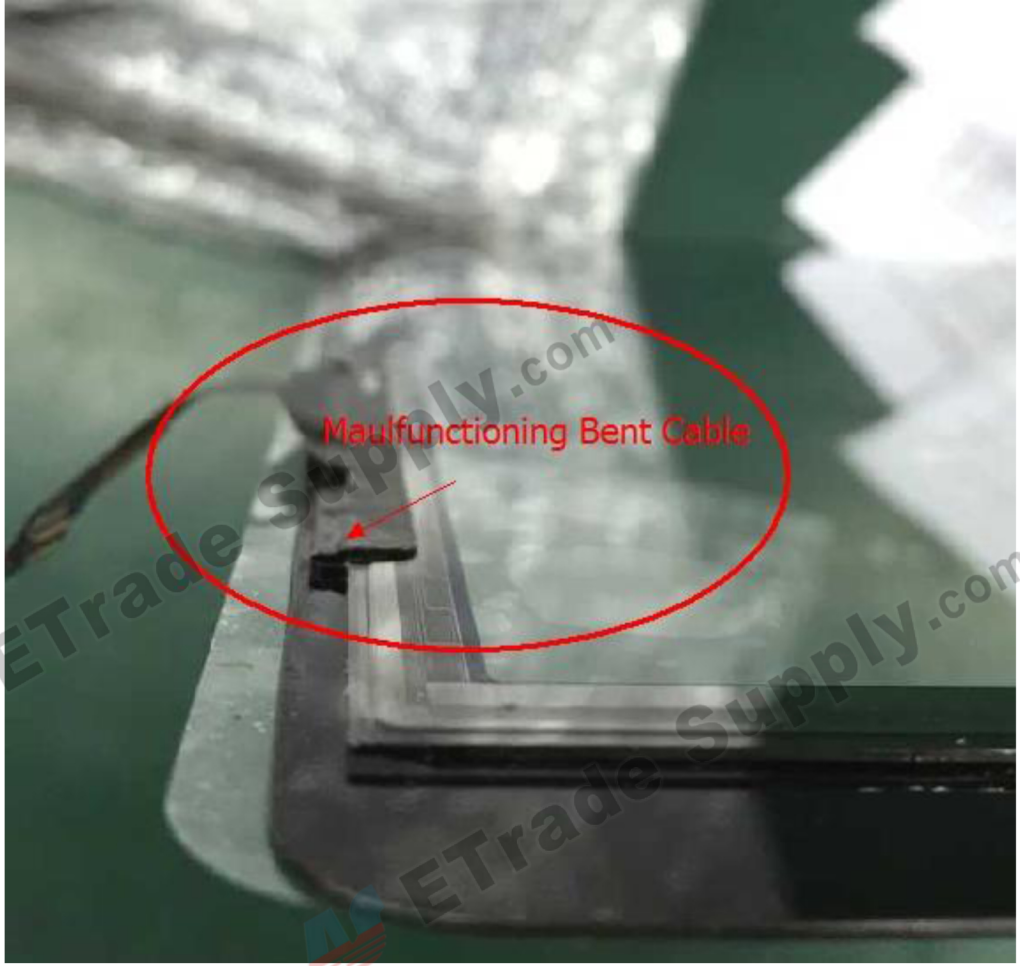
Though the issues may seem similar the causes behind them are not the same. After inspection and analysis, we think this issue is caused by an overly folded flex cable.

You can see the difference in the pictures below:

There are circuits in the flex cable for transmitting signals to the board so that users can interact with device. However, we don't usually pay much attention to [the flex ribbon](#) on the device. From now on, repair community, we should always be more careful when handling flex cables since they fragile like the IC's on [the iPad Minis](#), or have your techs not bend the cable while installing the touch panels either and see if the situation improves.

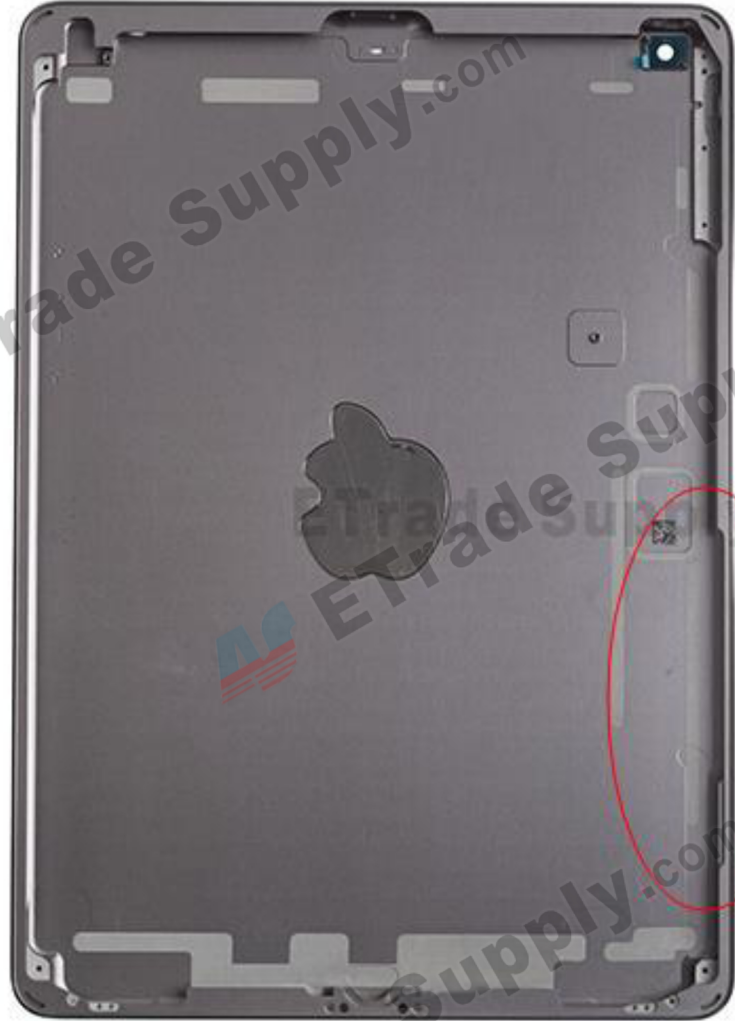
Additionally, Apple even designed a special area on [rear housing](#) for the cables to sit, which prevent the cable from bending.
