How To Fix Vertical Lines On An iPhone Screen After Replacement

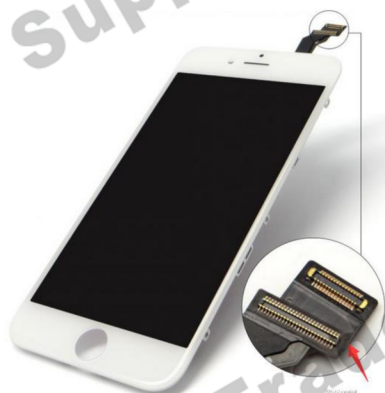
Reason: first thing you should do is check the connection between the flex cables and the logic board. If the connectors are obstructed by dust or debris, try to clear them away with a brush and rubbing alcohol. If the connectors are damaged or the flex ribbon is bent over 90° , well, a replacement is needed. After checking those, reconnect the flex cables to the motherboard, making sure the connectors are properly connected.

Solutions: do not force the connectors together until you are sure they are properly lined up; do not bend the flex ribbons during testing and installation.

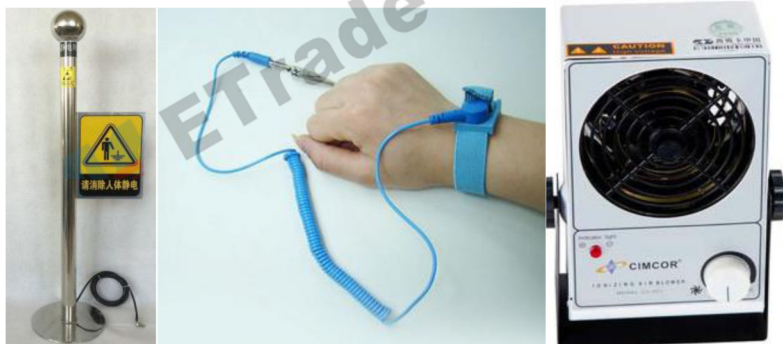
Reason: aside from a bad connection between flex ribbons and the logic board, ESD (Electro-Static Discharge) is another big cause of vertical lines. Too much ESD produced by either the product itself or by human during the test or installation.

Solutions: reduce any static charge by using a body static remover (or touching a ground) before proceeding with any testing or installation. Wear an anti-static bracelet and keep an ion fan on during the repair job.

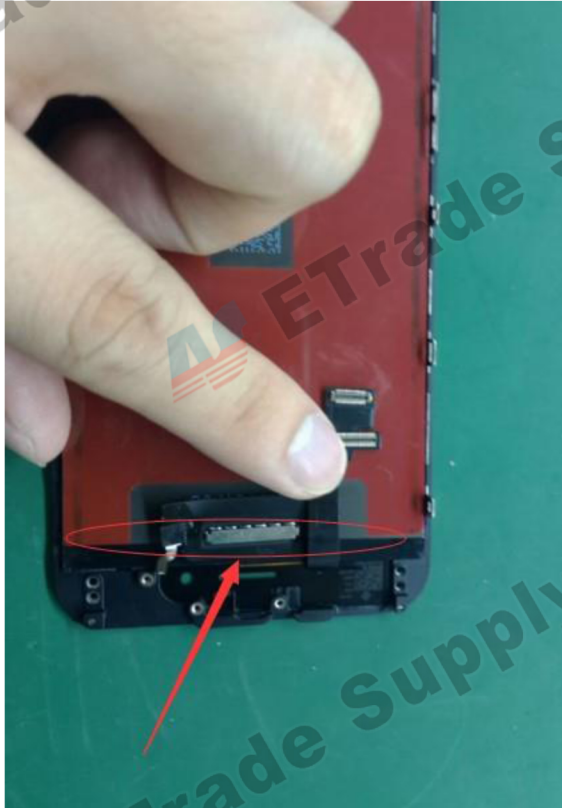
Reason: possibly the IC on the display is damaged if both of the above methods don't help. Check the part on the top left and right corners in particular. If there's any damage, or one of them has been crushed or the IC has been damaged then your part is defective. You'll have to replace the screen with a new one.

Solution: the screen has to be replaced if the IC was broken. Do not squeeze the IC to avoid damaging it.
